## Individual Section 4(f) Evaluation

**Route 199 over Shekomeko Creek  
Culvert Crossing (CIN C824084)  
Town of Pine Plains  
Dutchess County  
NYSDOT PIN# 8LC3.11**

U.S. Department of Transportation  
Federal Highway Administration  
and  
New York State Department of Transportation

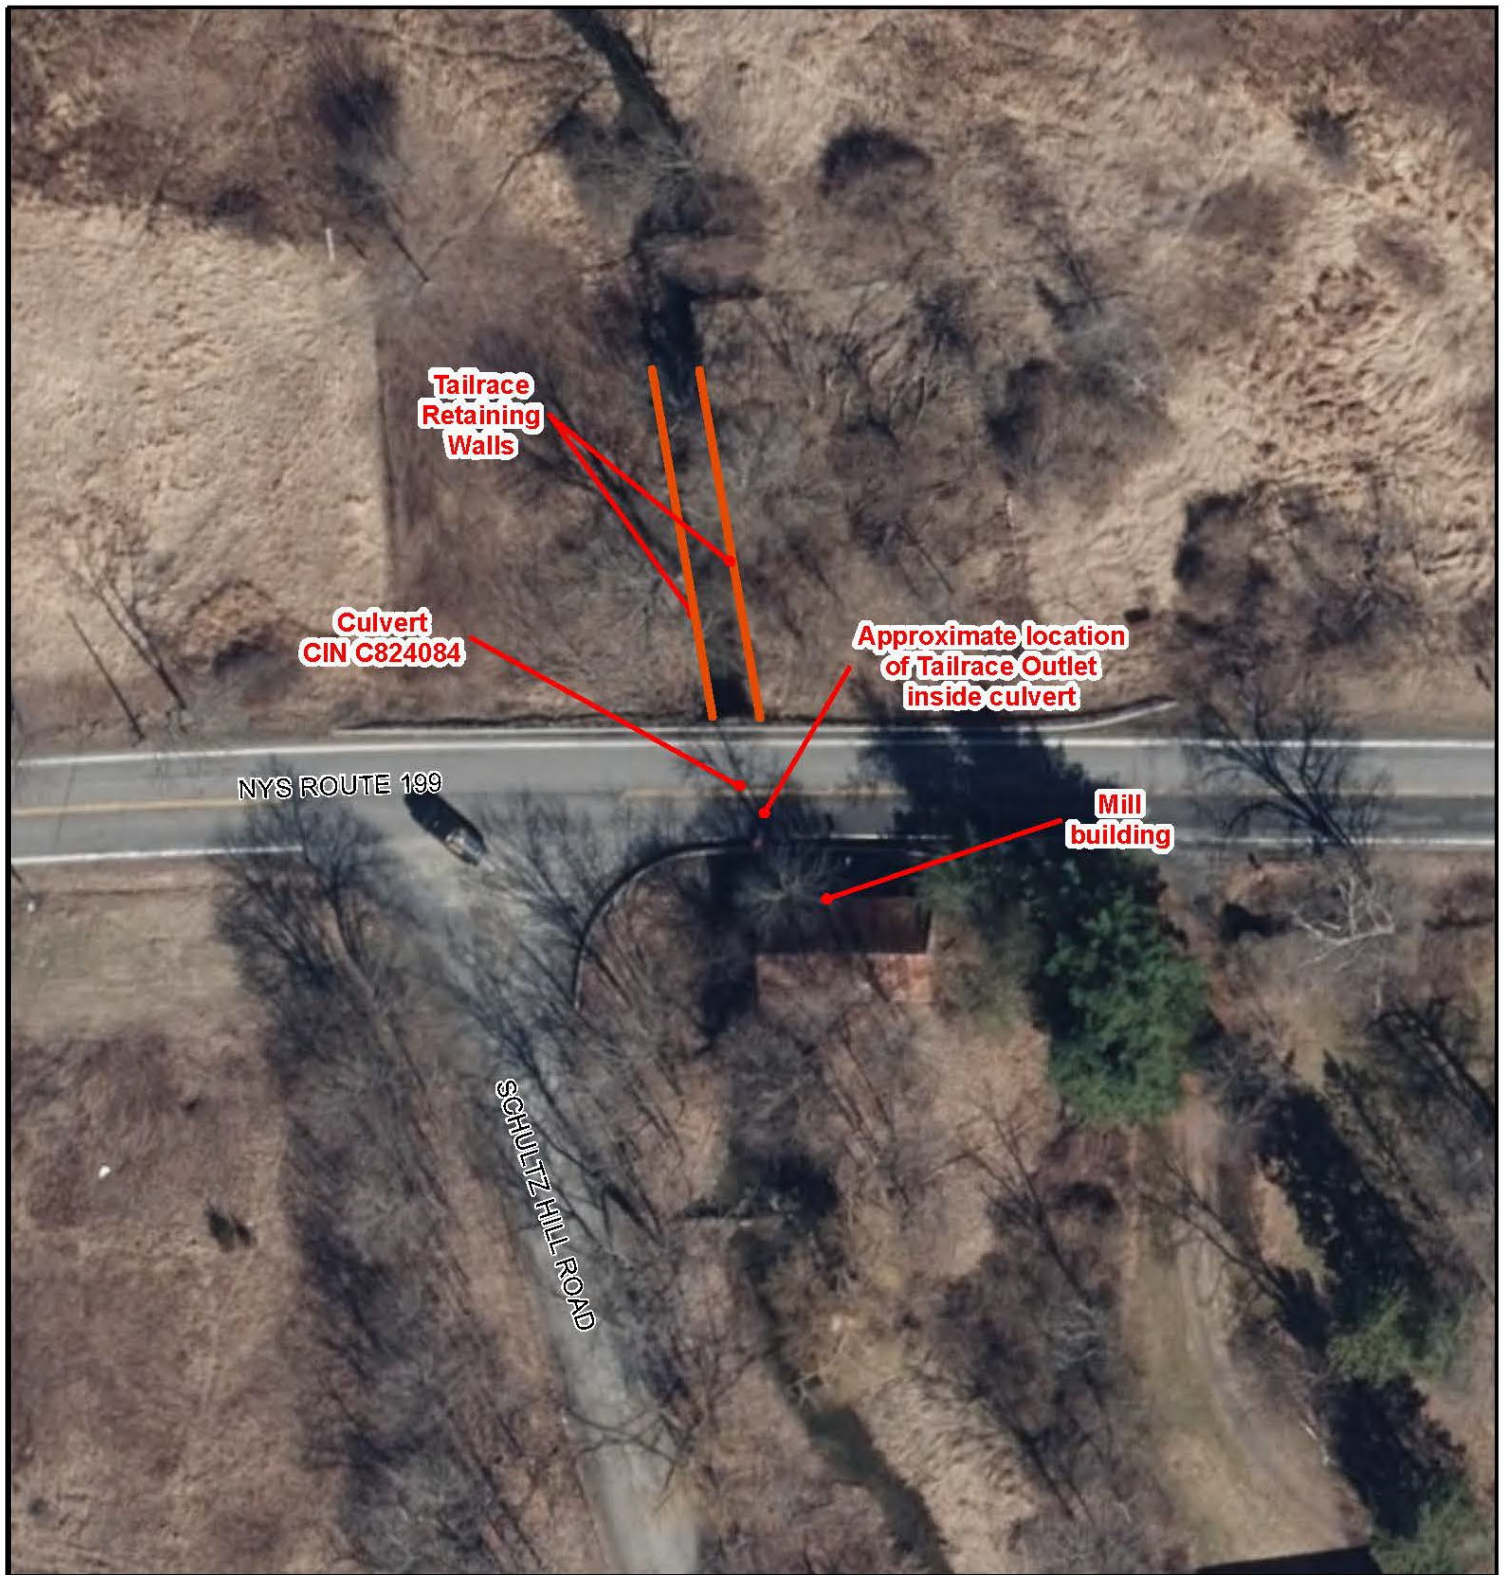
## SITE FEATURES

Rt. 199 Culvert Replacement  
CIN C824084  
Town of Pine Plains  
Dutchess County

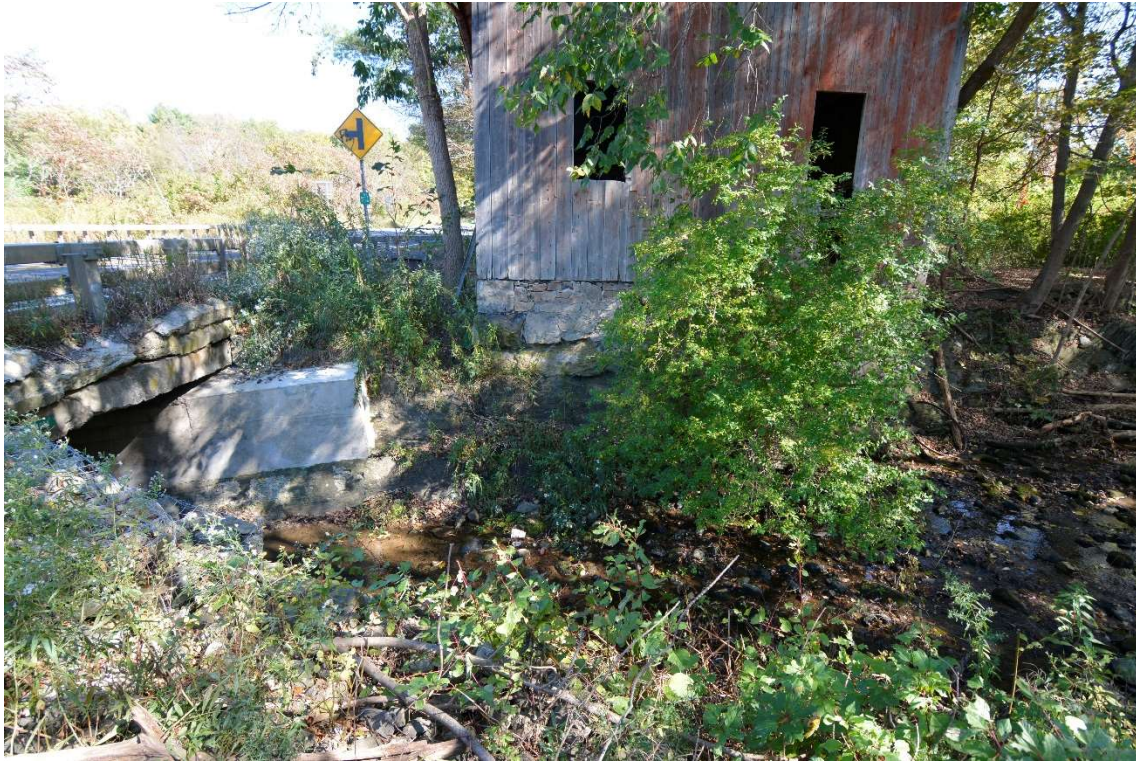
Looking east at the mill, with the culvert on the left side of the photograph.

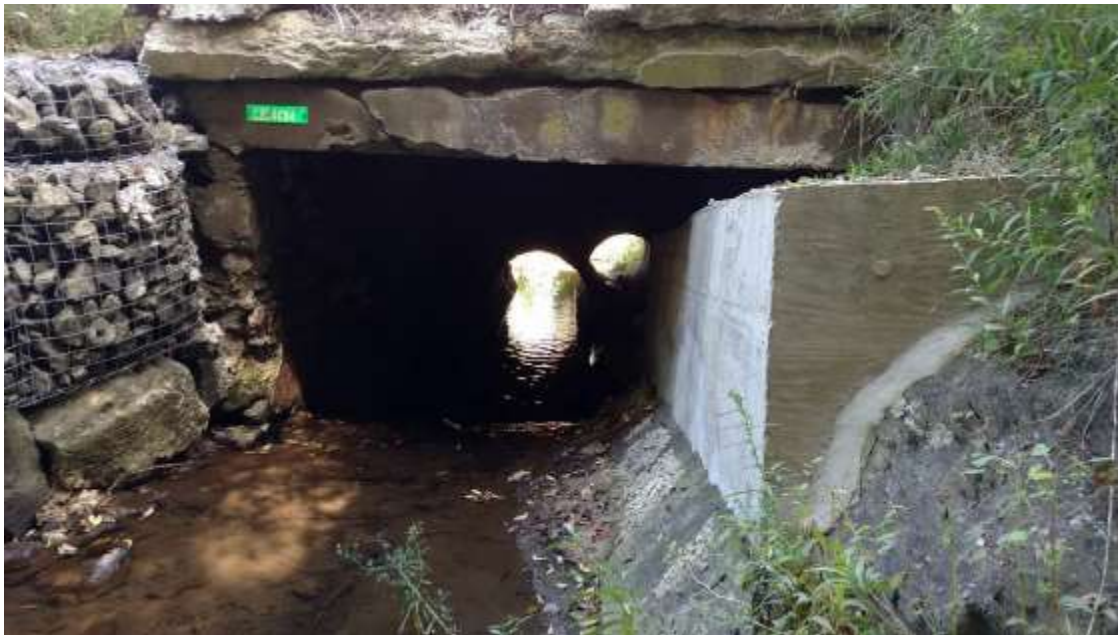
View north showing the south end of the culvert. The culvert was built directly on the surrounding bedrock. Note the concrete block on the east side (that was installed after culvert construction) that extends into the culvert.

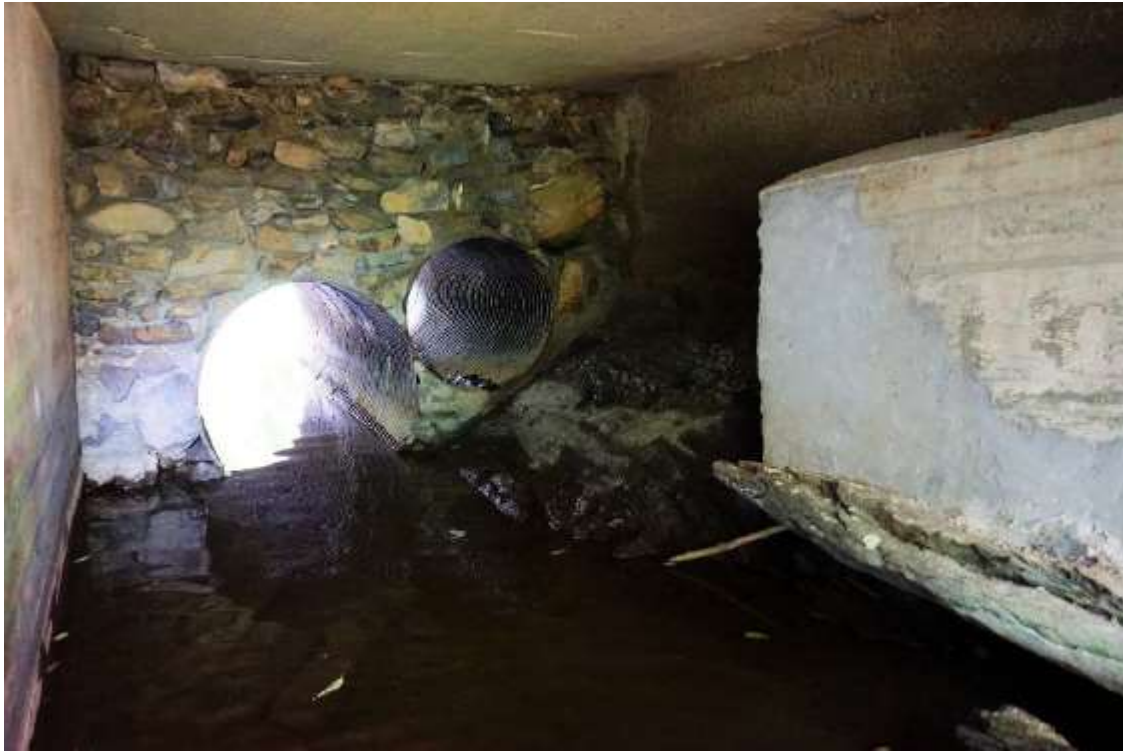
Interior current view of the culvert, looking north. Note concrete block extends into culvert.

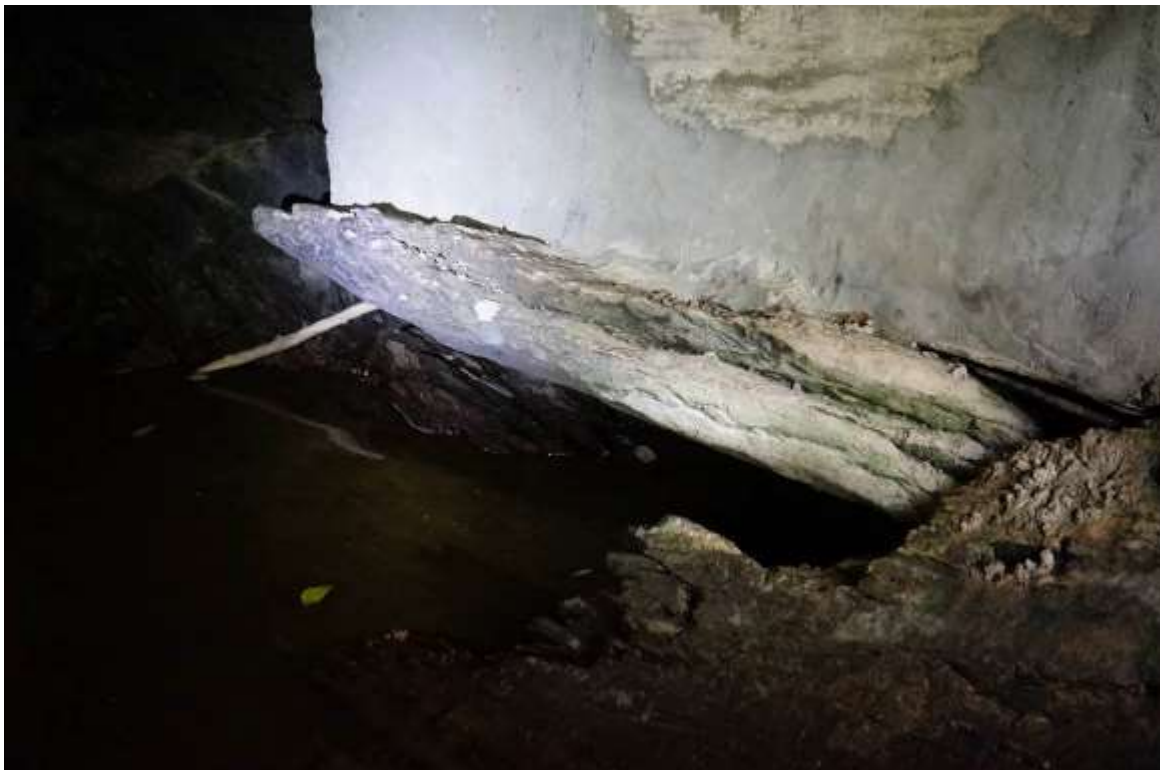
Current view of the opening in the bedrock at the midpoint of the culvert (east wall). This opening, found at the waterline at the midpoint of the east side of culvert (under the concrete block), is the outlet of the tailrace. The tailrace extends to the north side of the culvert, bordered by stone retaining walls.

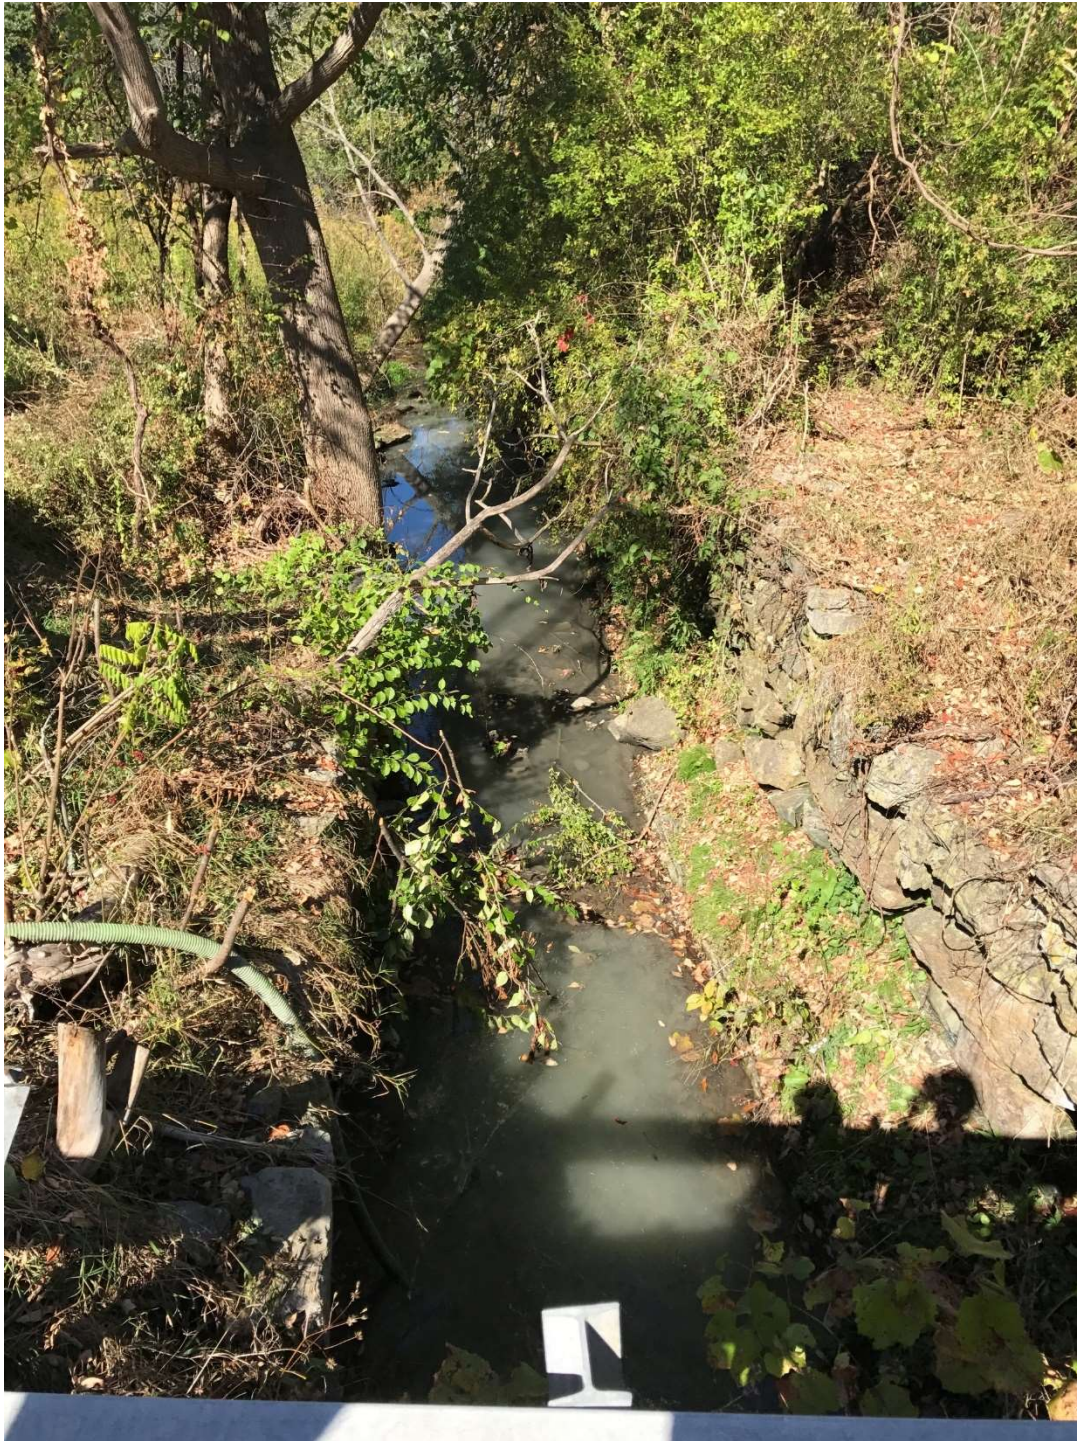
North side of Rt 199, looking north at the Shekomeko Creek and stone walls of the tailrace on the east and west sides of the creek.

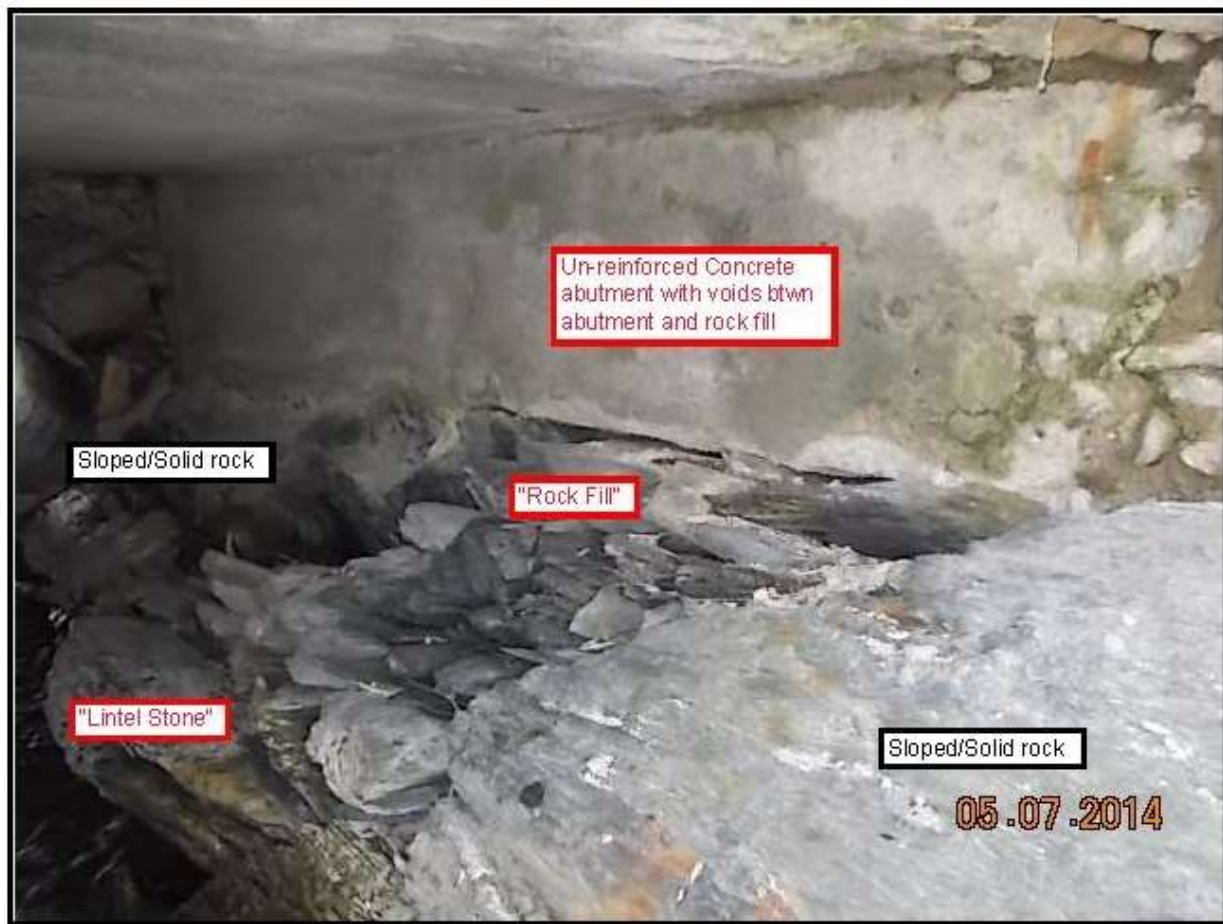
Photo prior to installation of concrete buttress.

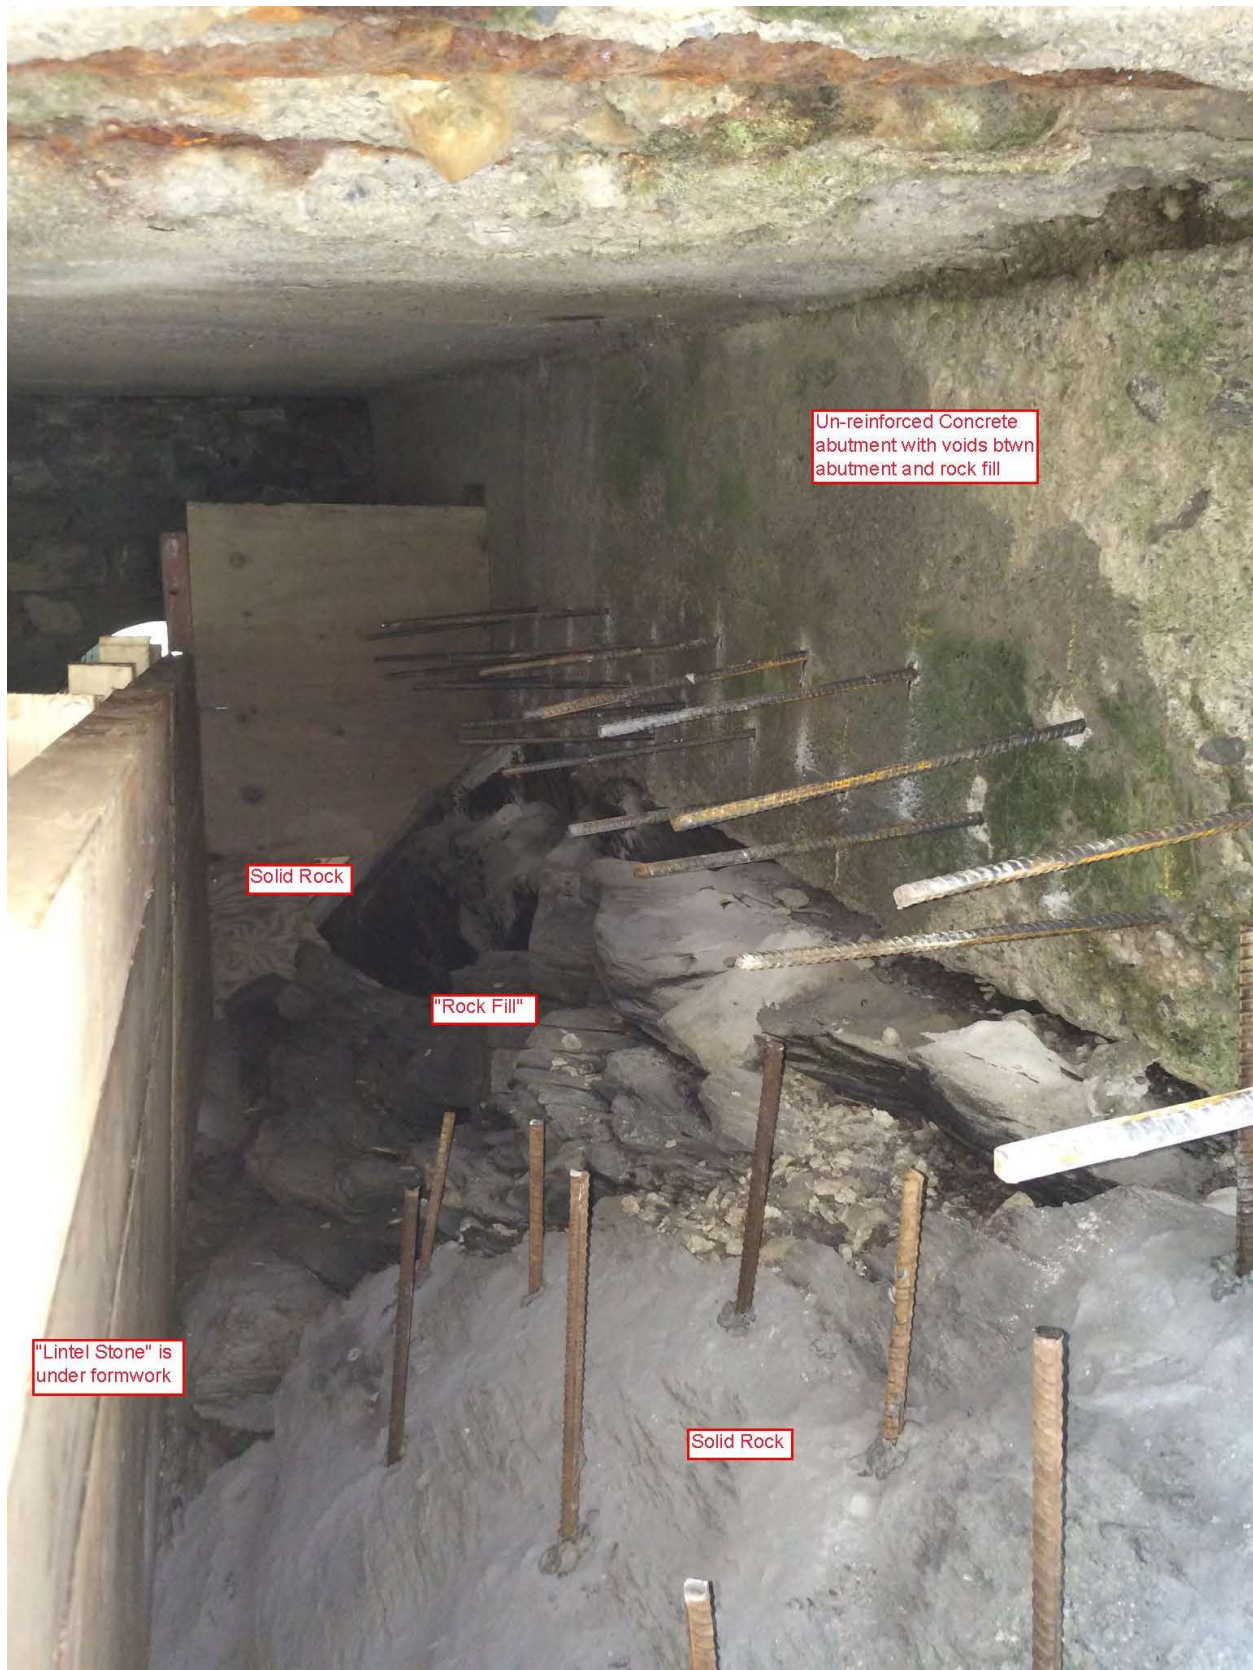
Photo during forming of concrete buttress, circa 2015.

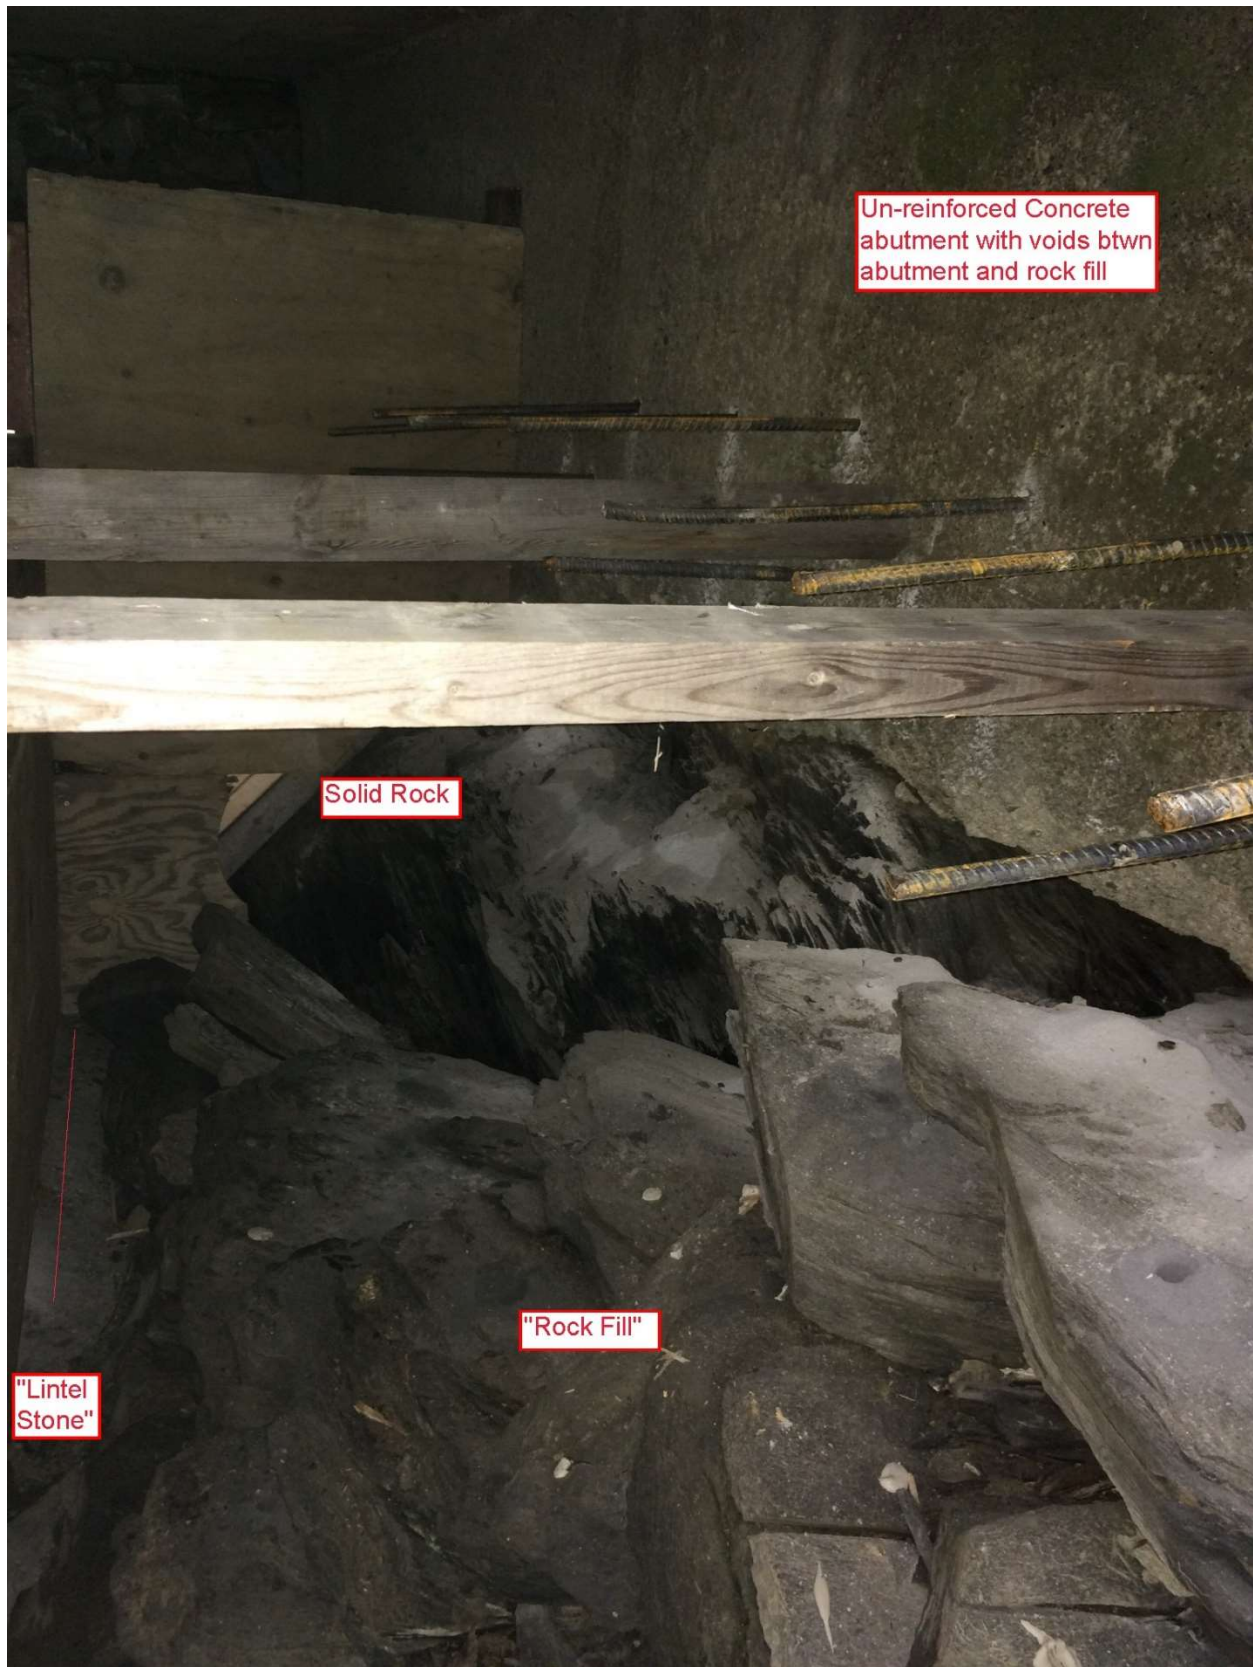
Photo during forming of concrete buttress, circa 2015.

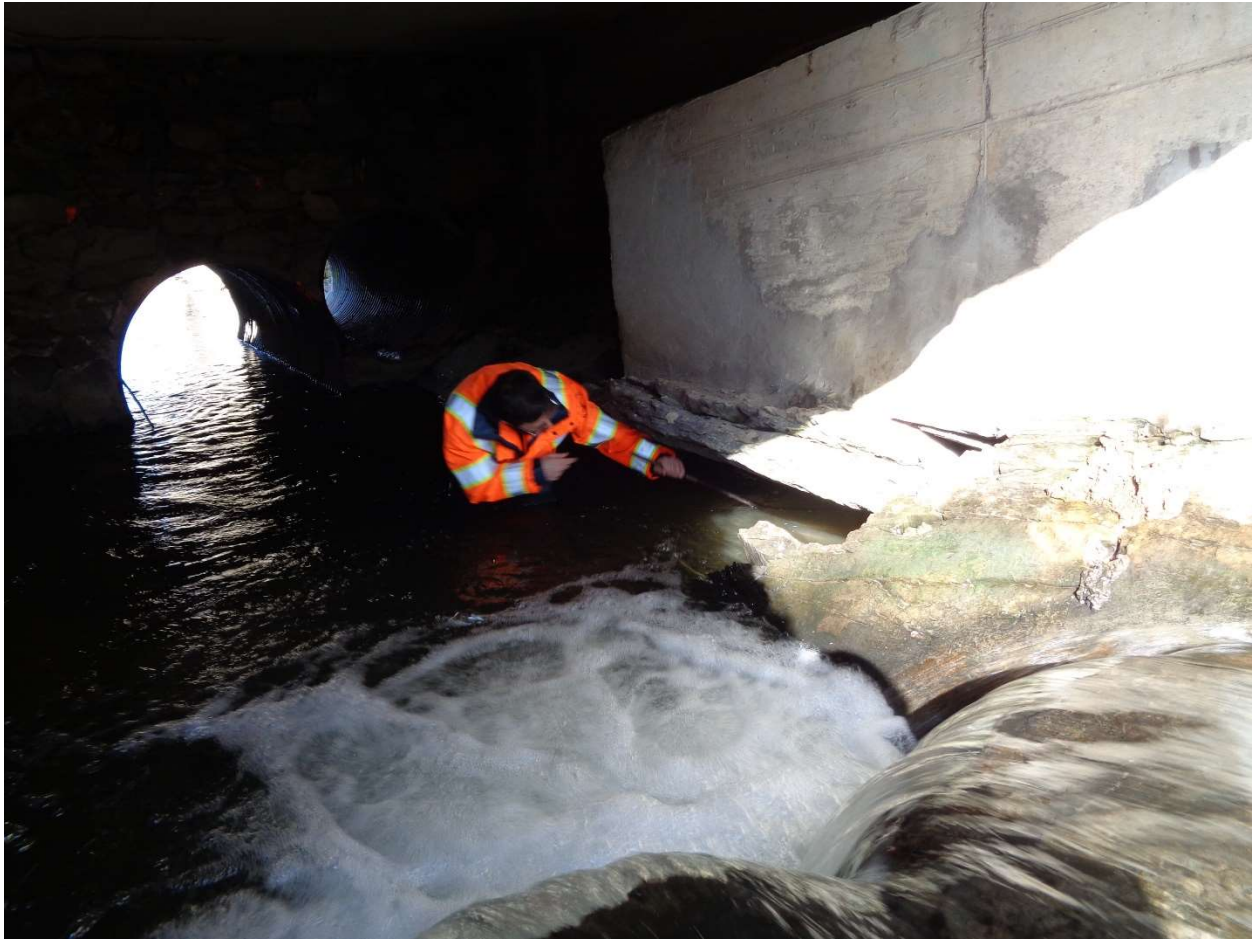
Investigation of tailrace outlet with probing rod. 2/15/2023.

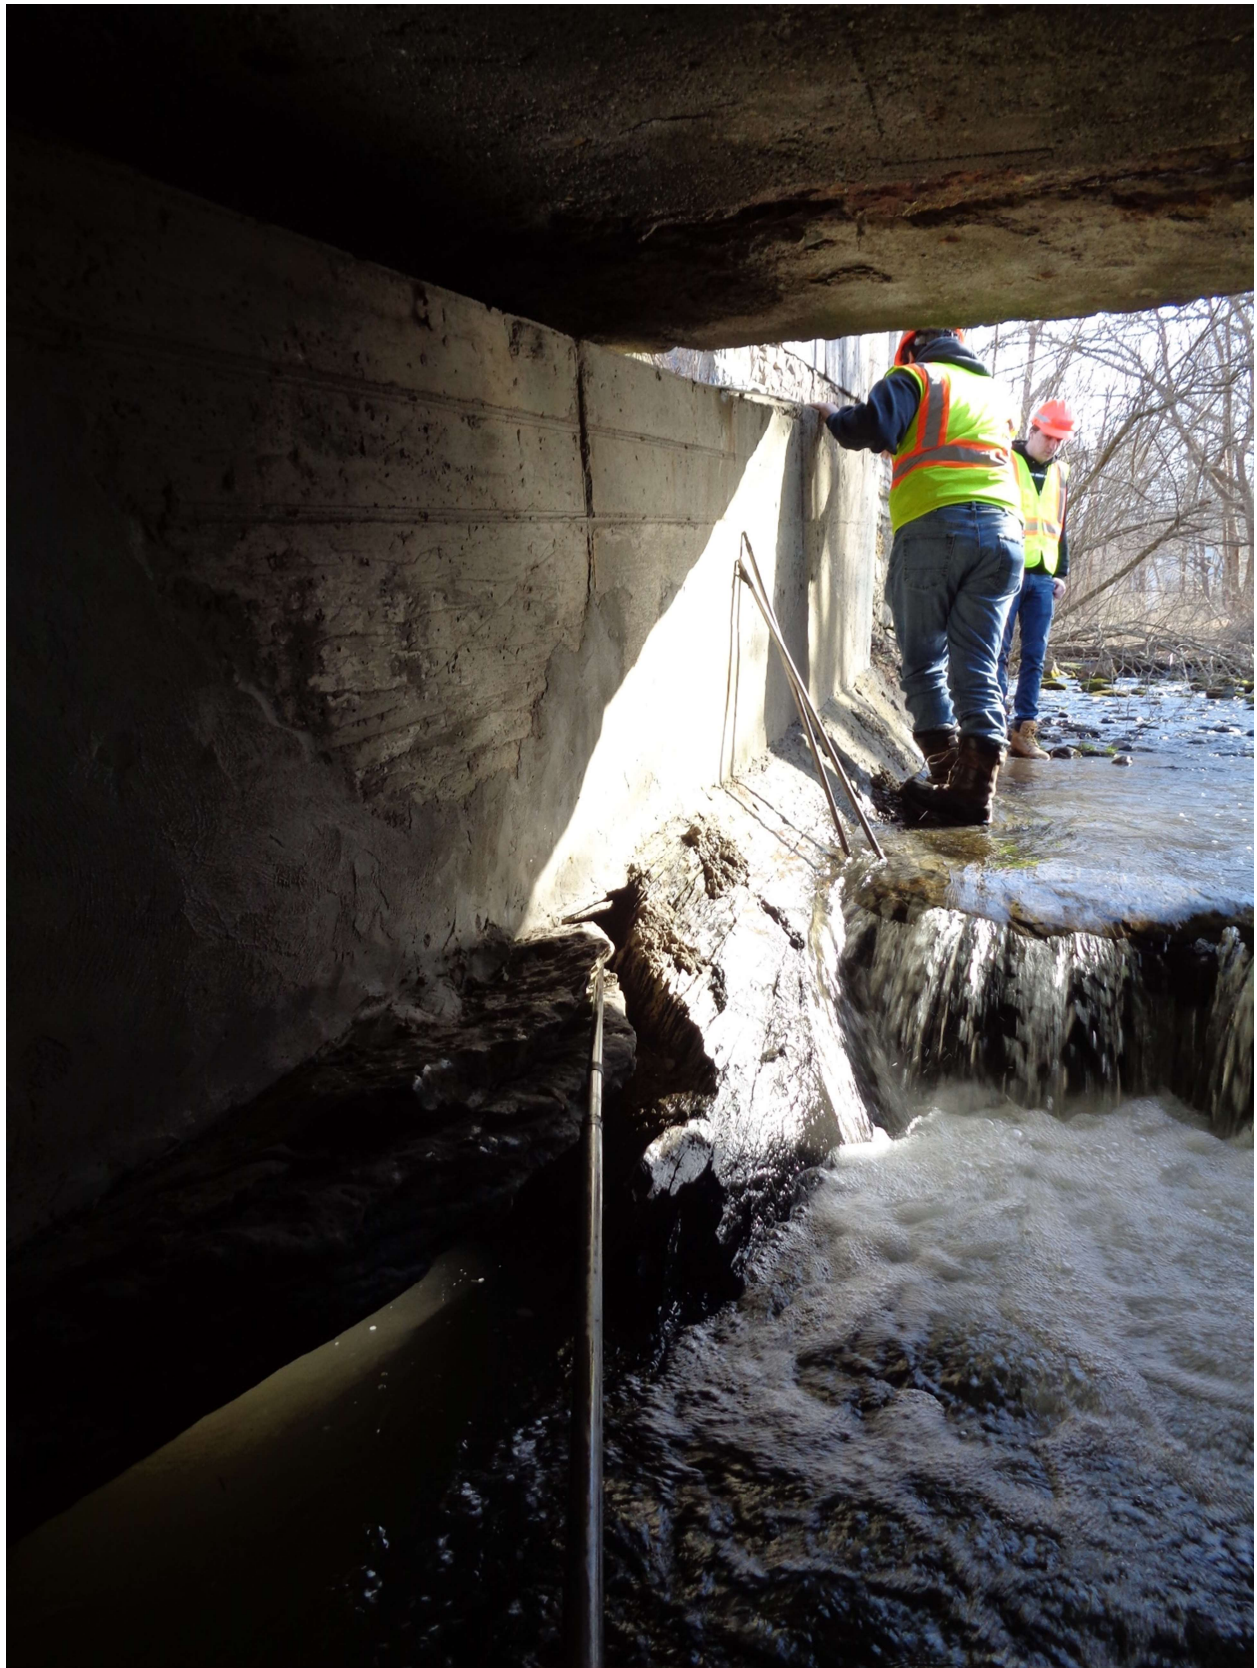
Investigation of tailrace. Probing rod is general line of tailrace. 2/15/2023.

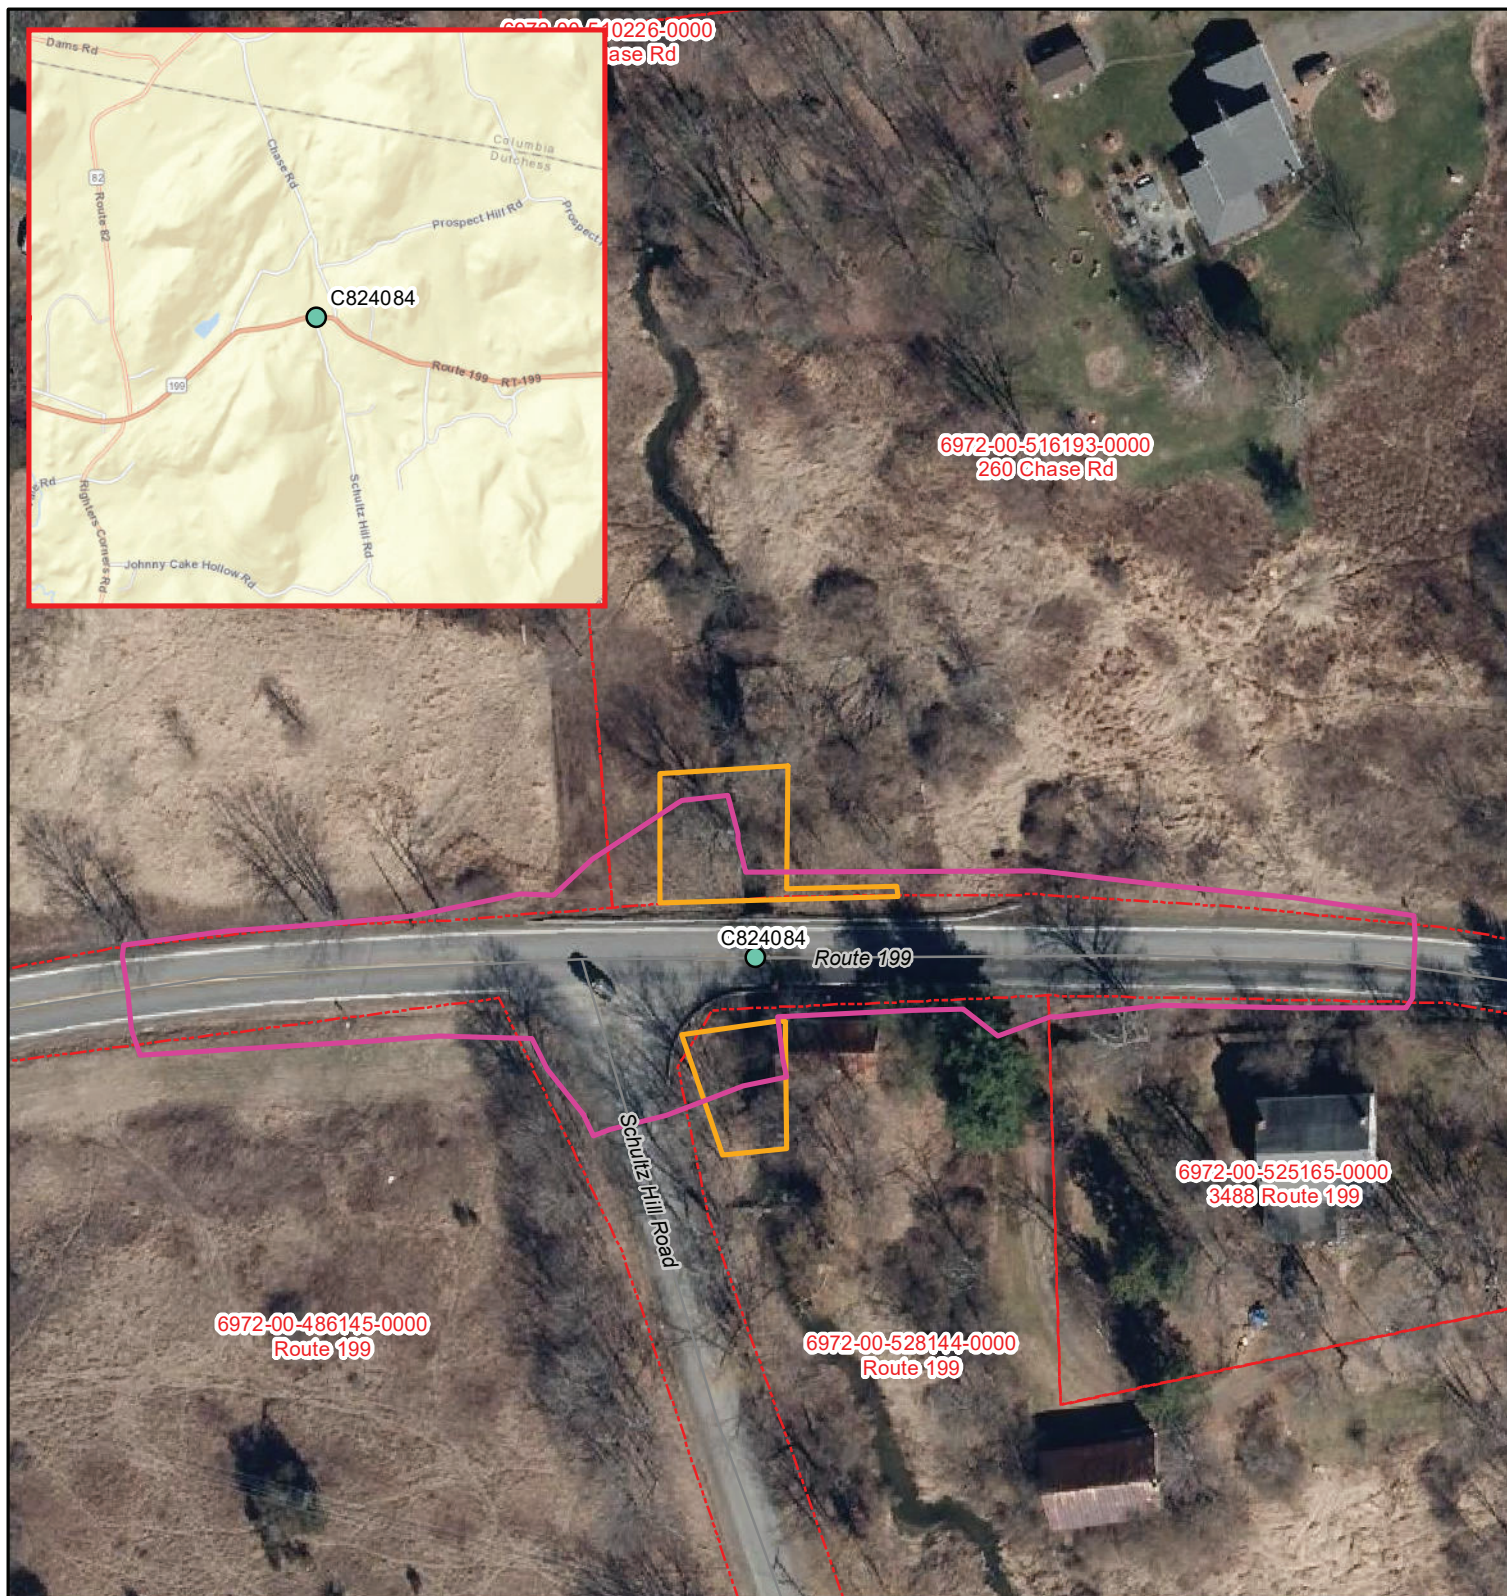
Currently-proposed disturbance limits  
 2017 survey limits  
 Tax parcels (approx)

1 inch = 75 feet
